MELSEC iQ-R System Recorder Use Case

Record the entire operating status of the system and perform simple analysis

The system recorder is a maintenance solution that "records the entire operating state of the system" when an error occurs, and allows "simple analysis" to significantly reduce downtime.

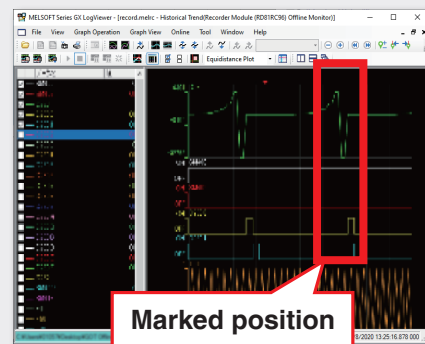
GX LogViewer

2 Checking the data around the marked time has shown that the vacuum pressure decreased before the "suction OFF" command was turned on.

Although the vacuum pressure error occurred in the suction part, the cause could not be identified since the dropped workpiece was **accidentally** mounted in the incorrect position without alignment.

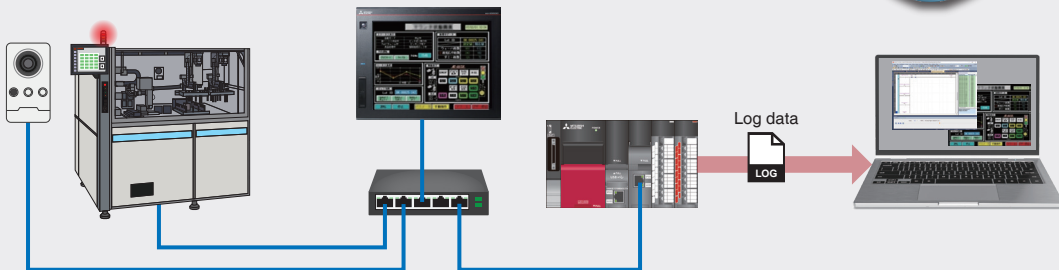
1

The operation before the error occurrence was checked in the **event history**.

Event history
Page 13

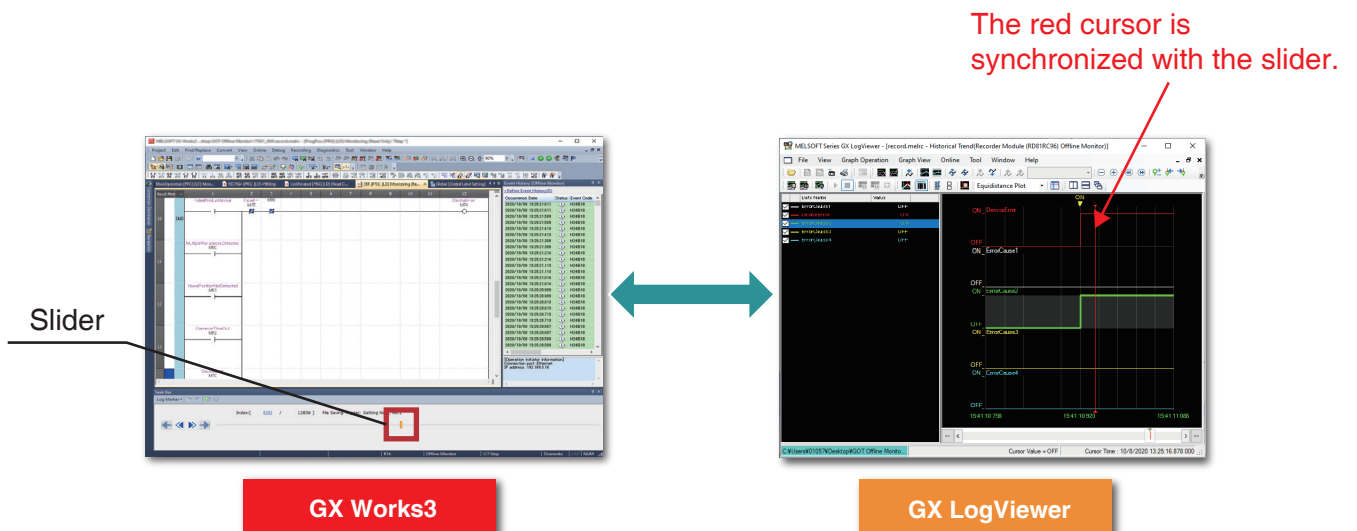
Offline monitoring

- ✓ By replaying data saved in the recorder module using the offline monitor, the state at the time of the error can be reproduced in the engineering tool.
- ✓ You can check the circuit monitor (program transition) with GX Works3 and the waveform data with GX LogViewer. By moving the slider on the seek bar, the program, waveform data, and operation history can be synchronized and played.

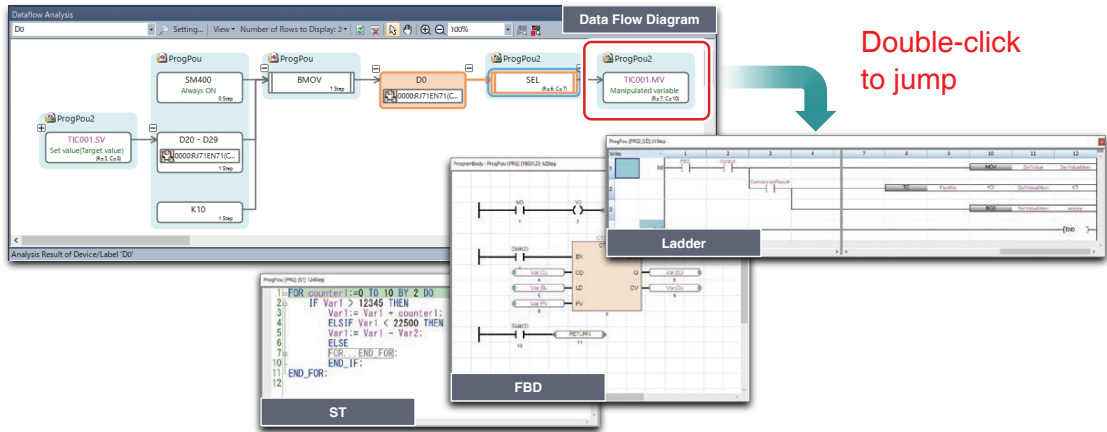
Data flow analysis function

- ✓ A device flowchart is automatically created from the program of GX Works3, and the related data is visually displayed.
- ✓ Comments and instruction diagrams are also displayed in the flowchart.
- ✓ Double-clicking an item in the flowchart jumps to the window for the corresponding device/label.
